A Hybrid Living Shoreline Approach to Protect Carrot Island, a NC Estuarine Research Reserve

Margaret R Boshek PE Senior Coastal Engineer Moffatt & Nichol Mboshek@moffattnichol.com

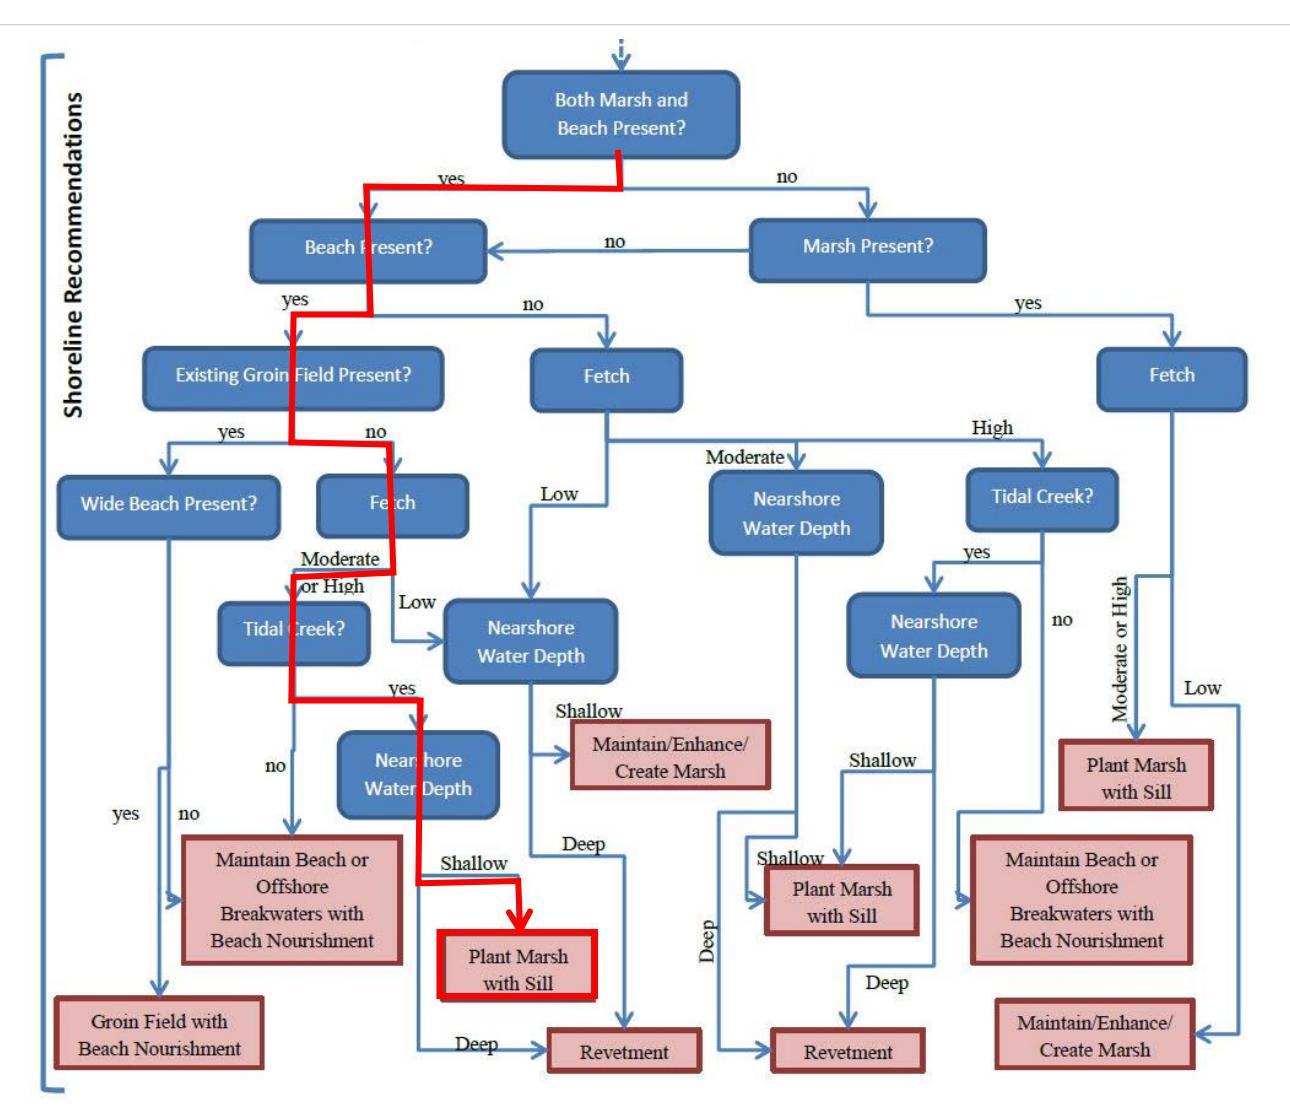
Shoreline Management Model: Preferred Shoreline Best Management Practices

> The Shoreline Management Model assumes that the shoreline is unstable.

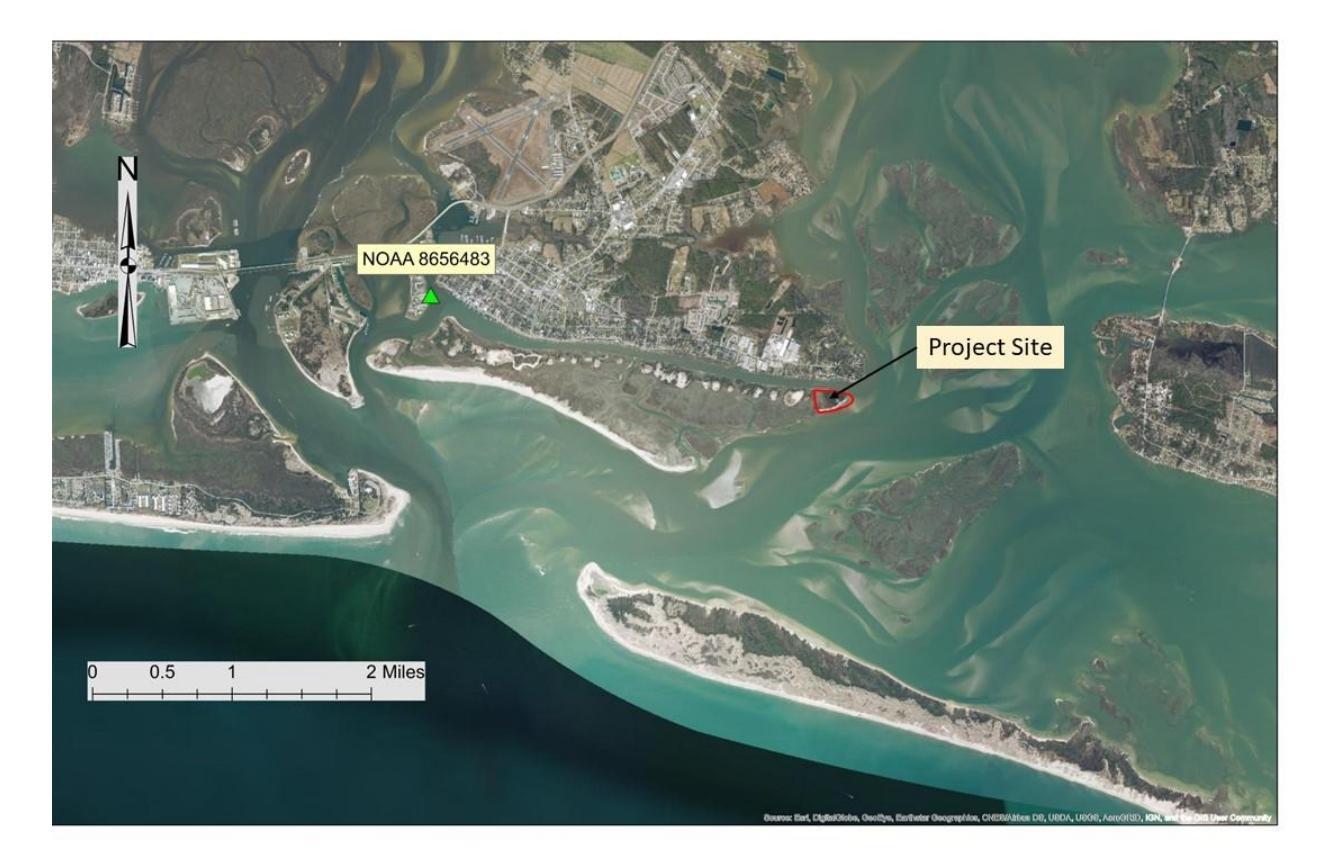
Design Water Levels – Normal Conditions

Percent Exceedance	Water Level (ft, NAVD88) M&N 2004-2022 epoch				
99%	-2.51				
95%	-2.00				
MLLW	-1.88				
90%	-1.70				
MLW	-1.67				
75%	-1.09				
50%	-0.10				
25%	0.90				
MHW	1.48				
10%	1.56				
мннw	1.80				
5%	1.90				
1%	2.48

Design Water Levels for Wetland Platform Creation

- Between -1.7 & 1.56
- Based on survival of estuarine intertidal vegetation.

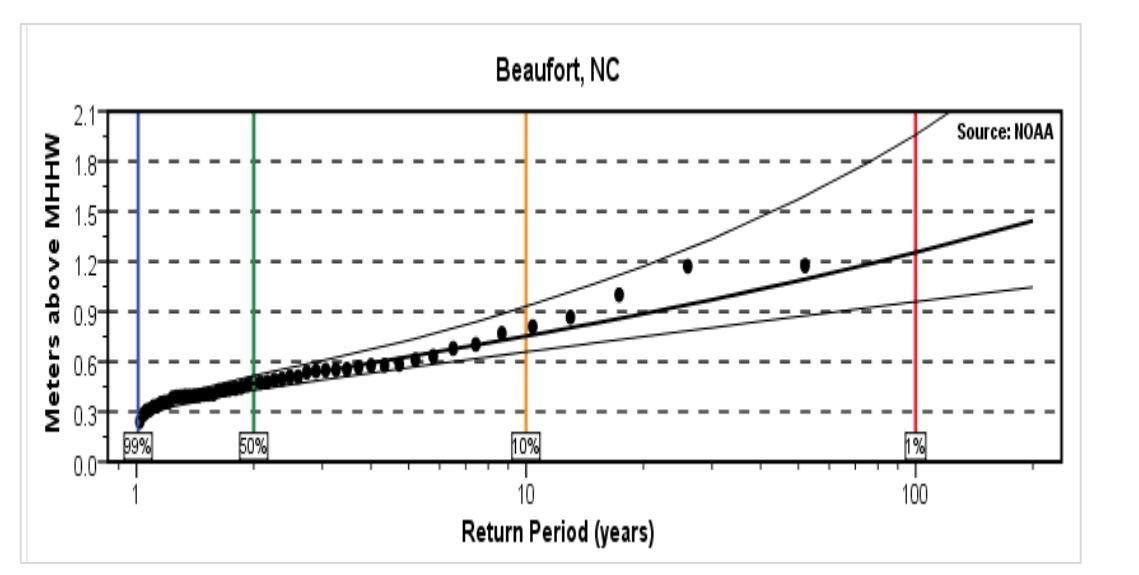
Design Water Levels – Storm Conditions

Return Period [year]	Elevation (ft, NAVD88)			
1-year	2.5			
2-year	2.9			
5-year	3.4			
10-year	3.9			
25-vear	4.4

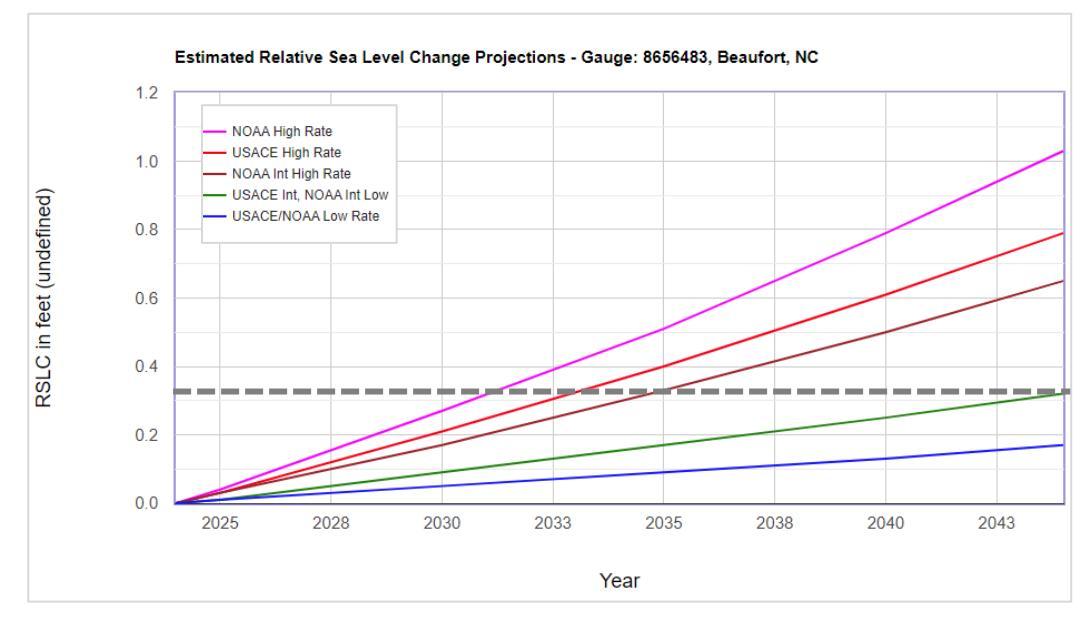
PLUS SEA LEVEL CHANGE!

Return Period [year]	Elevation (ft, NAVD88)			
1-year	2.8			
2-year	3.2			
5-year	3.7			
10-year	4.2			
25-year	4.7

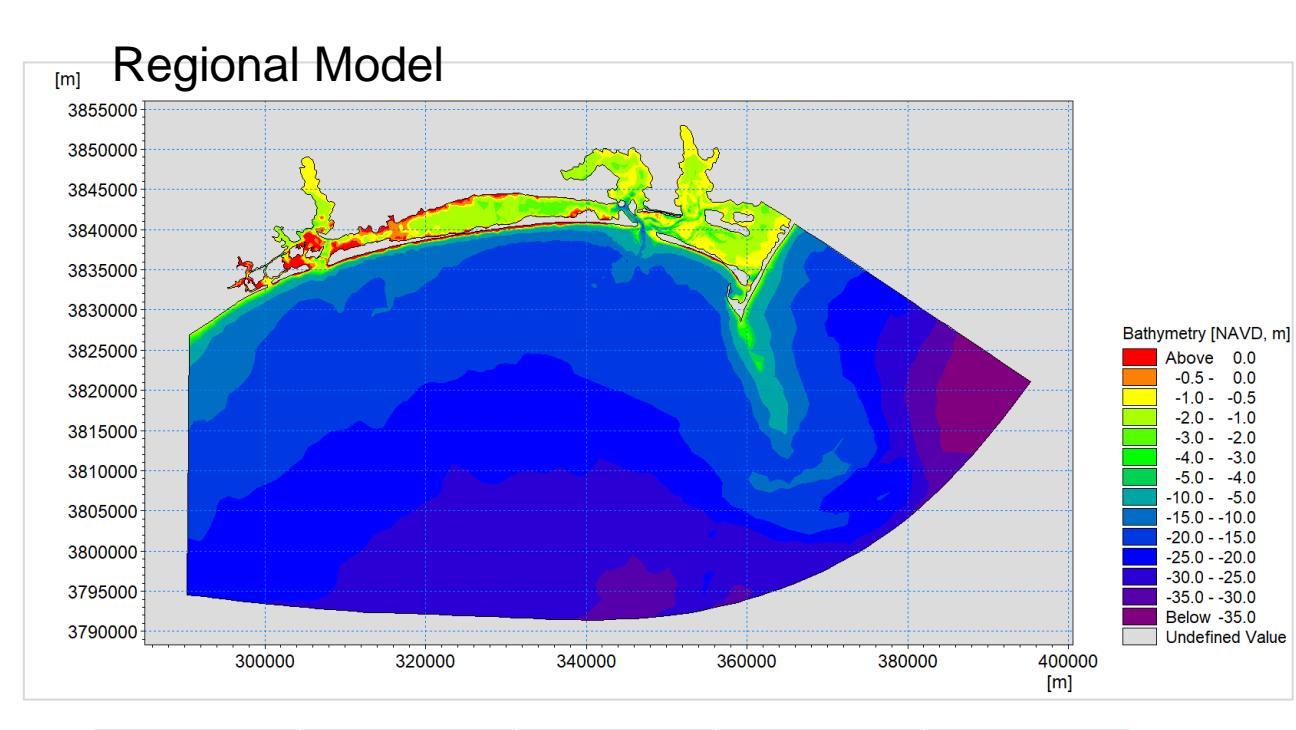
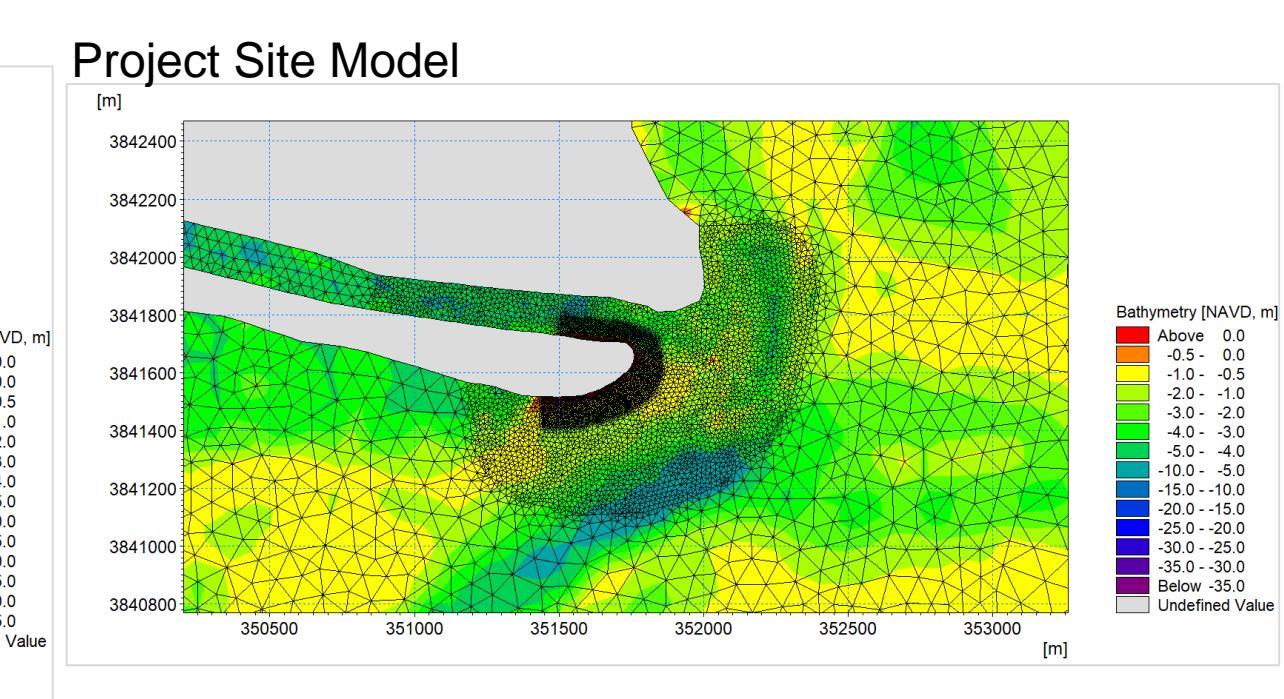
Wave Modeling

Туре	Annual Probability of Exceedance [%]	Water Level [ft,NAVD88]	Significant Wave Height [ft]	Peak Wave Period [sec]		
Normal	25%	1.2	0.3	1.7		
Normal	10%	1.9	0.4	1.7		
Normal	5%	2.2	0.5	1.8		
Normal	1%	2.8	0.6	2.0

Туре	Return Period [yr]	Water Level [ft,NAVD88]	Significant Wave Height [ft]	Peak Wave Period [sec]	
Extreme	1	2.8	2.0	2.9	
Extreme	2	3.2	2.2	3.0	
Extreme	5	3.7	2.5	3.1	
Extreme	10	4.2	2.7	3.2	
Extreme	25	4.7	3.0	3.4

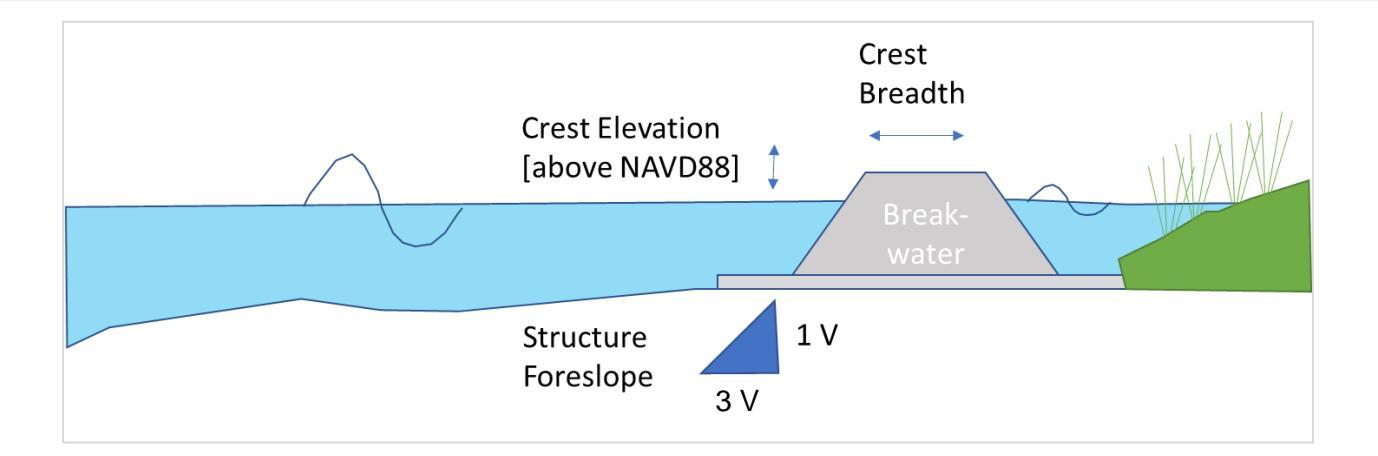
Modeled Wave Transmission Results

Where transmitted wave heights are greater than 0.5 ft, it is expected that the protected marsh restoration feature could experience erosion

Annual Prob. of Exceedance [%]	Water	Significant	Peak	Design Crest Elevation [ft,NAVD88]				
Туре		Period I [yr] I	Level [ft, NAVD88]	Wave Height [ft, NAVD88]	wave Period [sec]	1.0 Trans	2.0 smit ed [f	3.0 Wave H t]	4.0 leight
Normal	25%		1.2	0.3	1.7	0.2	0.0	0.0	0.0
Normal	10%		1.9	0.4	1.7	0.5	0.1	0.0	0.0
Normal	5%		2.2	0.5	1.8	0.6	0.2	0.0	0.0
Normal	1%		2.8	0.6	2.0	0.9	0.5	0.1	0.0
Extreme		1	2.8	2.0	2.9	1.2	0.8	0.4	0.0
Extreme		2	3.2	2.2	3.0	1.5	1.1	0.7	0.2
Extreme		5	3.7	2.5	3.1	1.7	1.3	0.9	0.5
Extreme		10	4.2	2.7	3.2	1.9	1.5	1.1	0.7
Extreme		25	4.7	3.0	3.4	2.2	1.8	1.4	1.0
